# Manhole Inspection Summary

Manhole # S11Q\_\_004MH

Insp Date: **4/8/09 7:16 AM**

**Location** Address: **707 S.Caton Ave.**

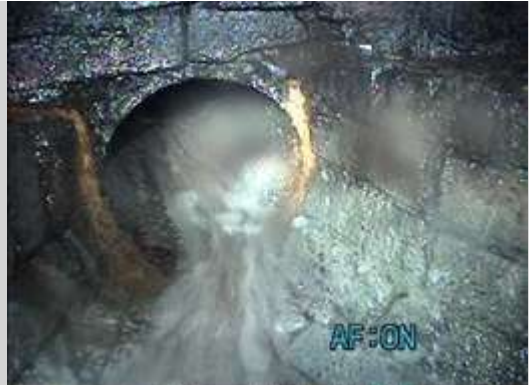
12 O'Clock Outflow

10 in. Circular Gravity Sewer  
Pipe Out @ 12 O'Clock

Pipe Height: **10.8** (in.) Rod and Bar (Angled)  
Pipe Material: **Clay** ☐ Pipe Lined  
Invert Depth: **17.49** (ft.) Flow Characteristics: **Fast**  
Deposits: ☒ None ☐ Mud ☐ Sludge ☐ Debris ☐ Grease  
Silt Depth: **0** (in.) Deposits Extent:  
Infiltration: **None** Pipe Seal Cond: **Sound**

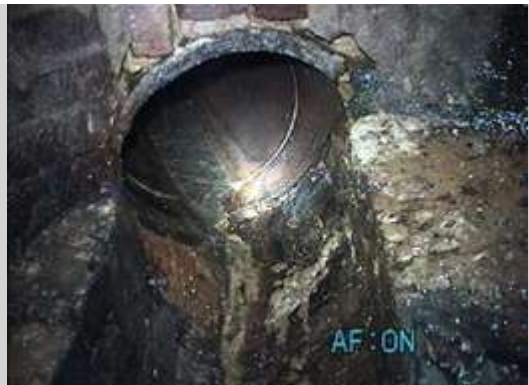
3 O'Clock Inflow

15 in. Circular Gravity Sewer  
Pipe In @ 3 O'Clock

Pipe Height: **15.6** (in.) Rod and Bar (Angled)  
Pipe Material: **Clay** ☐ Pipe Lined  
Invert Depth: **17.20** (ft.) Flow Characteristics: **Slow**  
Deposits: ☒ None ☐ Mud ☐ Sludge ☐ Debris ☐ Grease  
Silt Depth: **0** (in.) Deposits Extent:  
Infiltration: **None** Pipe Seal Cond: **Sound**

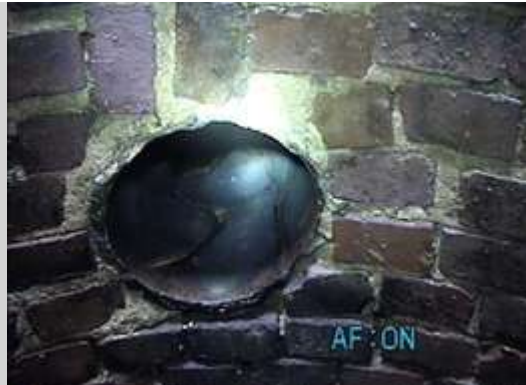
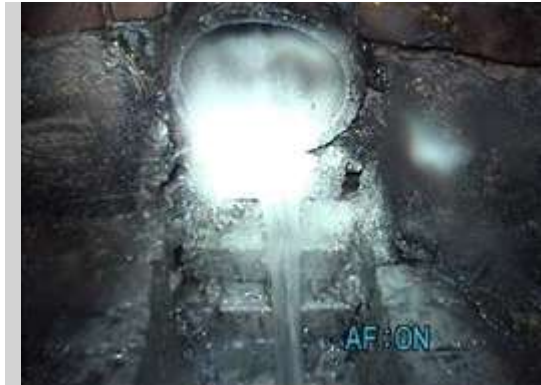
6 O'Clock Inflow

8 in. Circular Gravity Sewer

Pipe Height: **8.4** (in.) Rod and Bar (Angled)

Infiltration: **None** Pipe Seal Cond: **Sound**

Drop Condition: **Open**
